Navajo Abandoned Uranium Mine

Site Screen Report

NA-0504 AUM Site

Weston Solutions, Inc.

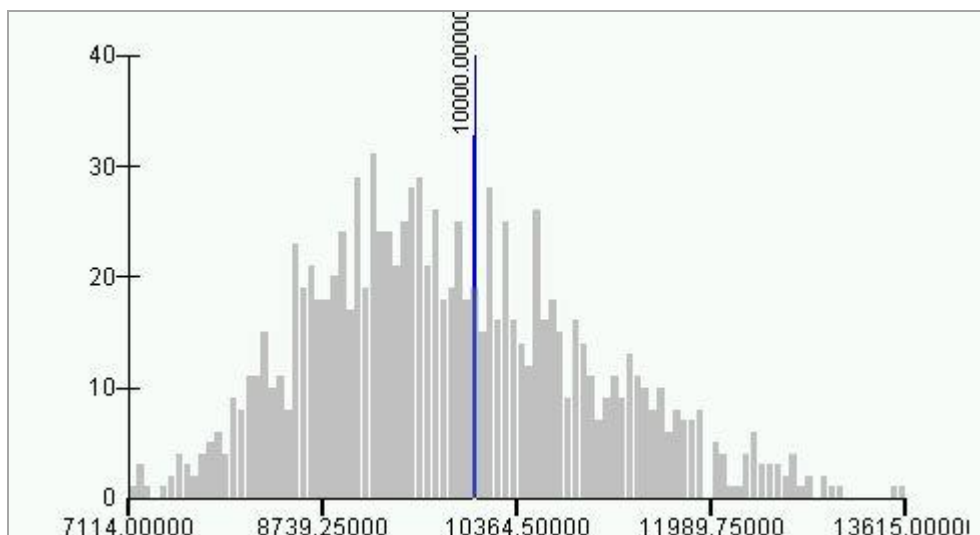
The following chart and statistics were generated by ESRI ArcGIS 9.3.1, and show the general distribution of the site gamma radiation measurements. The horizontal X axis represents the gamma radiation reading levels in cpm (lowest levels to the left). The vertical Y axis represents the frequency of each gamma radiation level.

Count:	1075
Minimum:	7114.00000
Maximum:	13615.00000
Sum:	10538806.00000
Mean:	9803.54047
Median:	9680.00000
Standard Deviation:	1156.03642

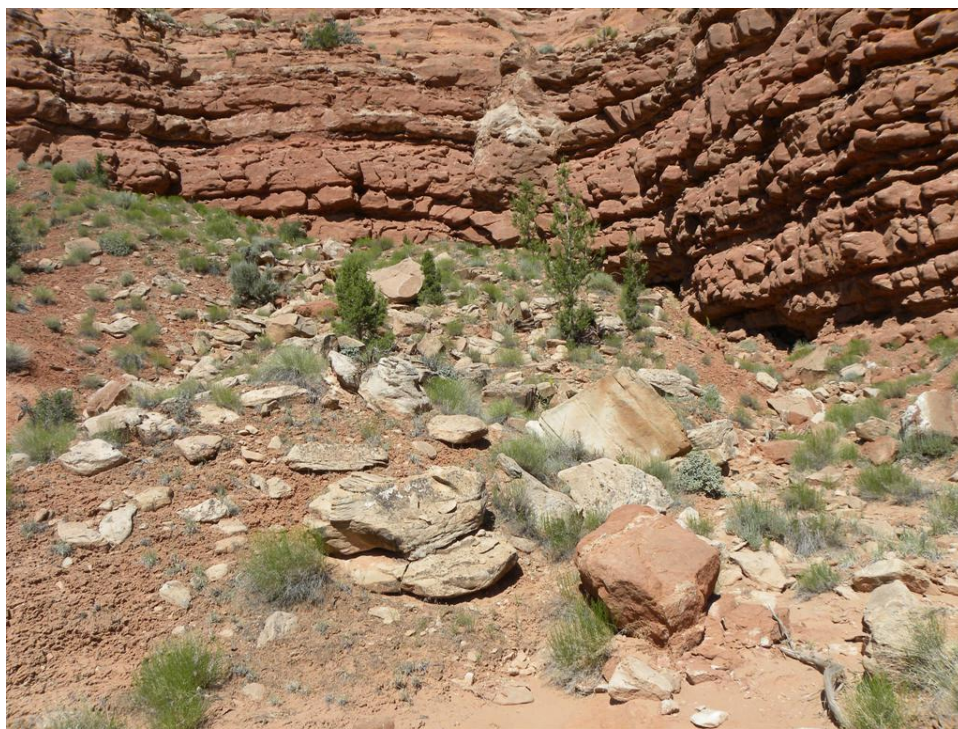
Rock pile at base of cliff 20'x50'x5'

Photo 2. NA-0504 site, waste pile

Unreclaimed waste rock

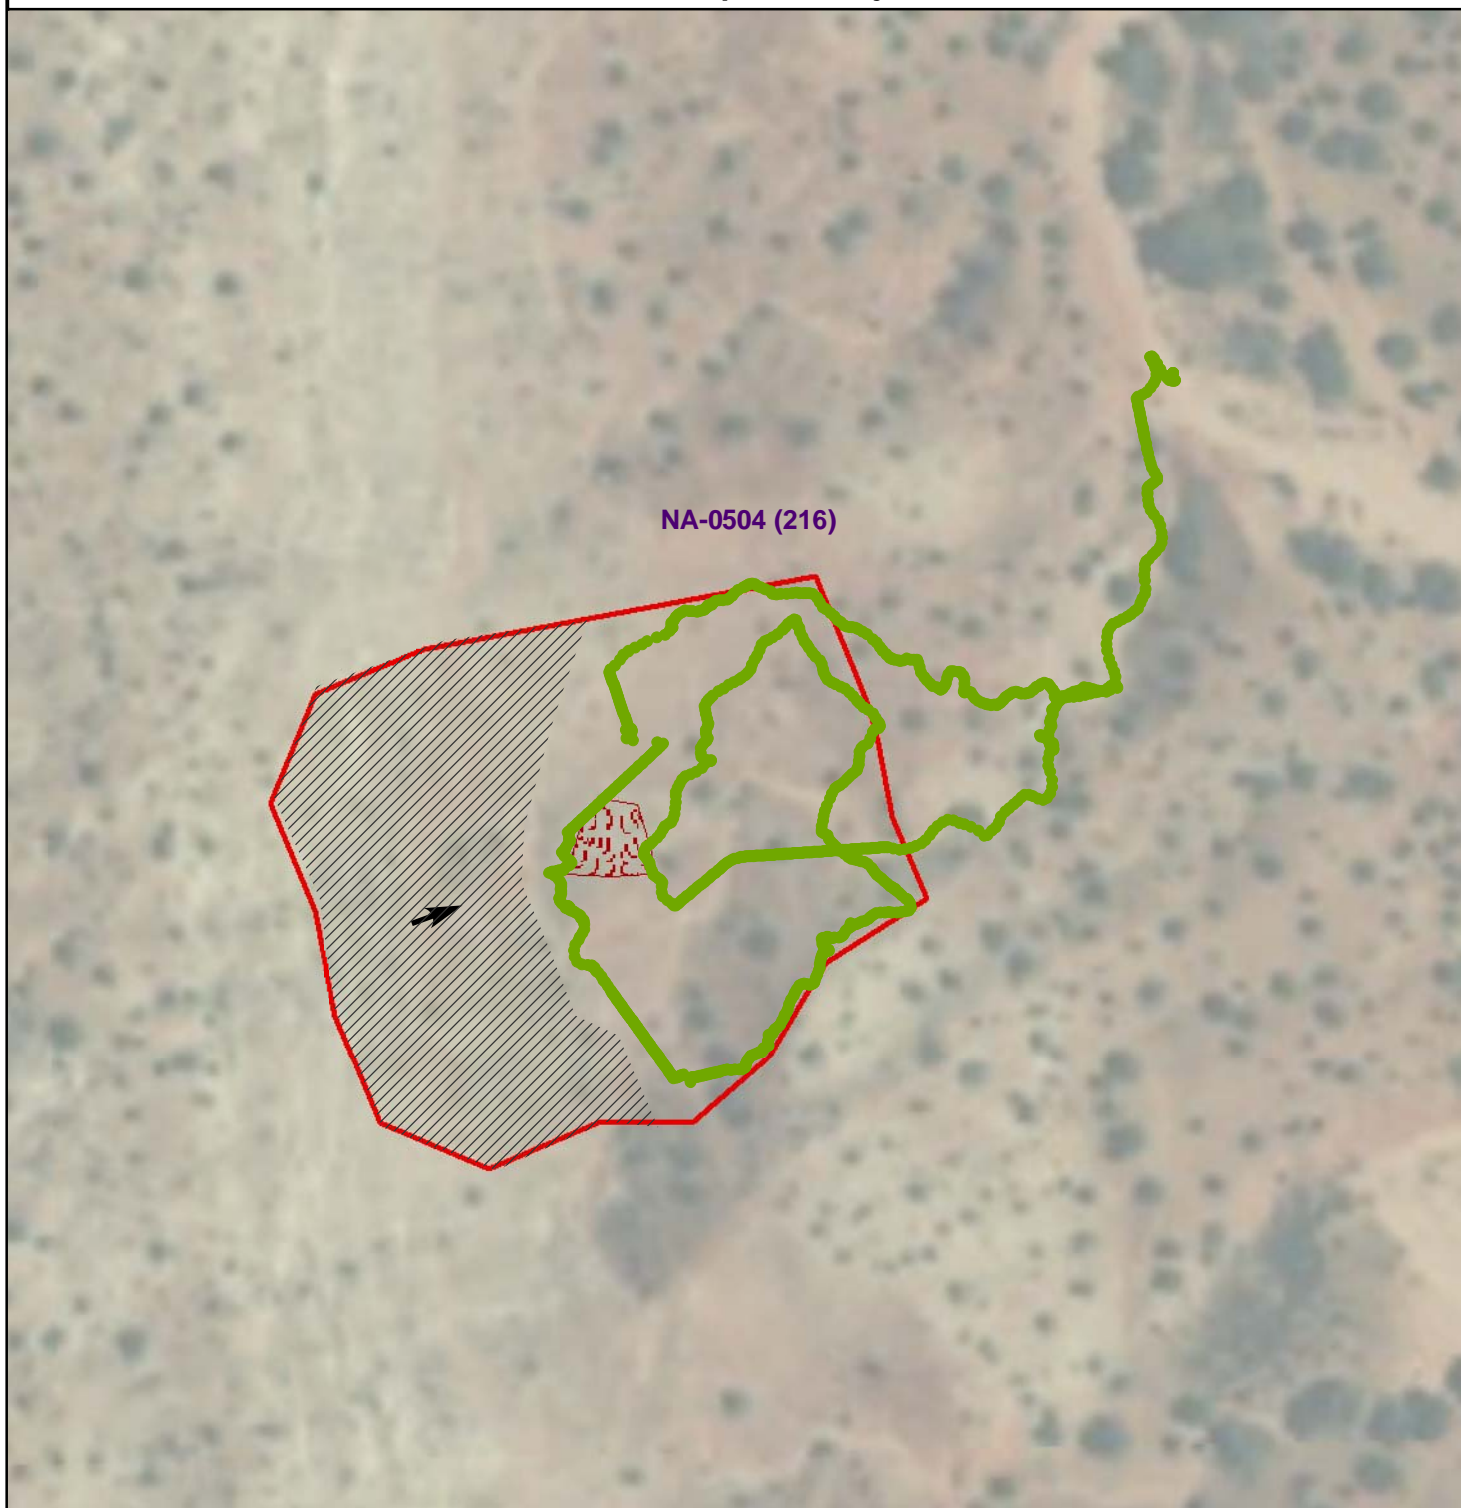
A total of 1,075 gamma radiation measurements were collected from the mine site, ranging from 7,114 cpm to 13,615 cpm. Measurements collected in the vicinity of the waste debris were found at levels ranging from approximately 10,000 cpm to 15,000 cpm. The measurements are represented in Figures 1 and 2.

**Figure 1 - Gamma Radiation Measurements, Above Two Times Background
NA-0504 (216)
Sweetwater Chapter, Navajo Nation**

Gamma survey conducted 06/2010
Measured as counts per minute (cpm)

Average background = 7,491 cpm

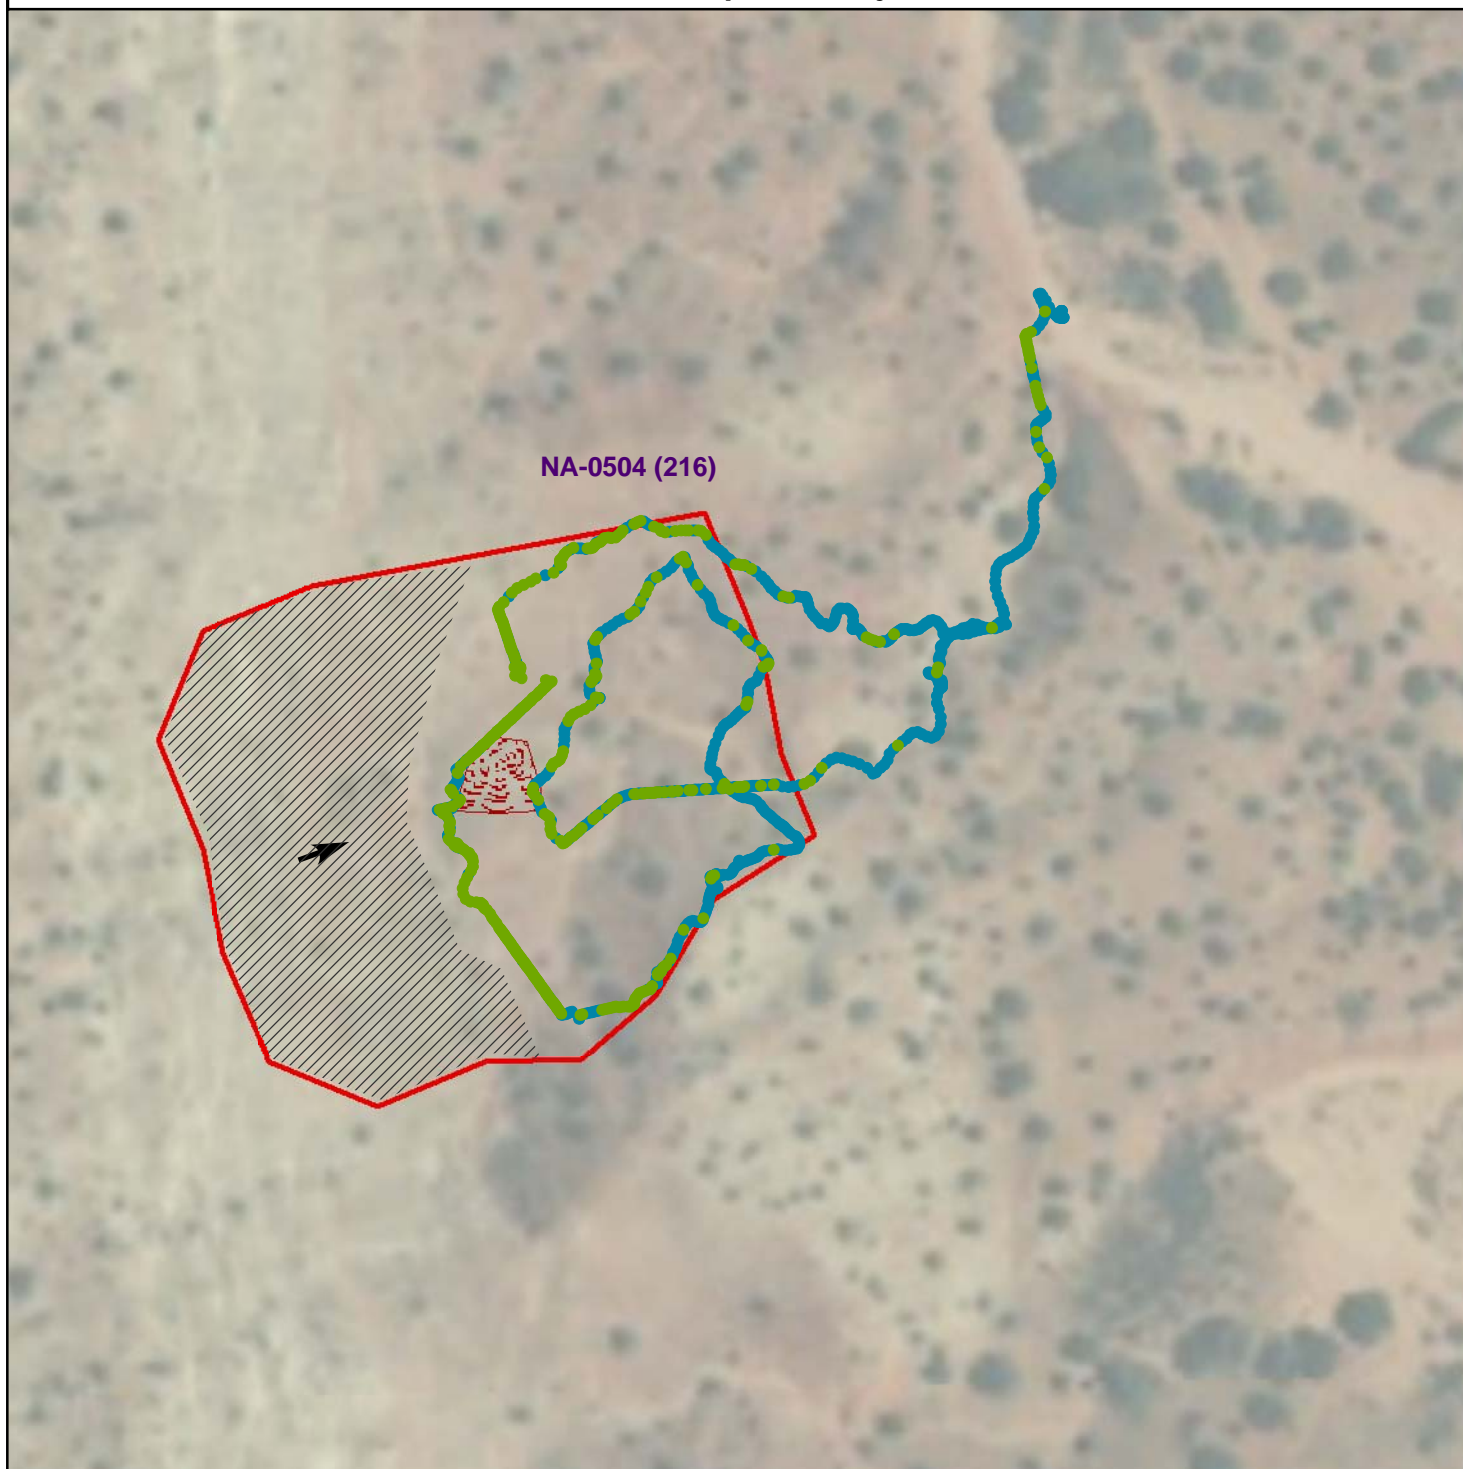
**Figure 2 - Gamma Radiation Measurements
NA-0504 (216)
Sweetwater Chapter, Navajo Nation**

Gamma survey conducted 06/2010
Measured as counts per minute (cpm)

Average background 7,491 cpm
